A STUDY OF ROADWHEEL FAILURES MAGNITUDE - NATURE -  
CAUSES AND TESTING OF A CONCEPT TO PREVENT THEM

TECHNICAL REPORT NO. 12080

FINAL REPORT

JOHN W. CAMERON  
PROJECT ENGINEER  
USATACOM

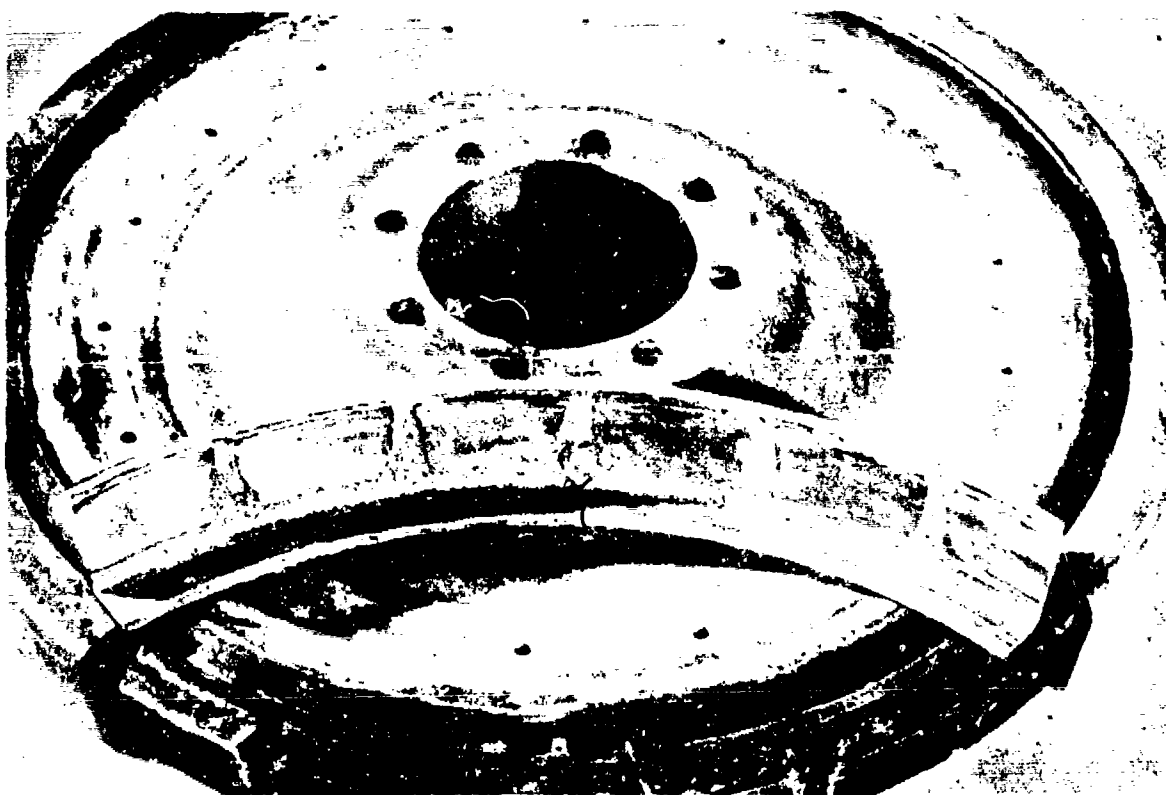
Returning to the evaluation of the steel shrouded wheel, approximately eight wheel samples were sent to the metallurgist for examination. Some of these wheel samples were unfractured and others fractured. One had a crack just starting on the inside diameter of the steel shroud flange. The metallurgical report is included in Appendix II.

FIGURE 12 - Wheel #2 on Which Shroud Was Cracked but Still Not Broken After 998 Miles. Section Was Sawed From Shroud to Study Crack.

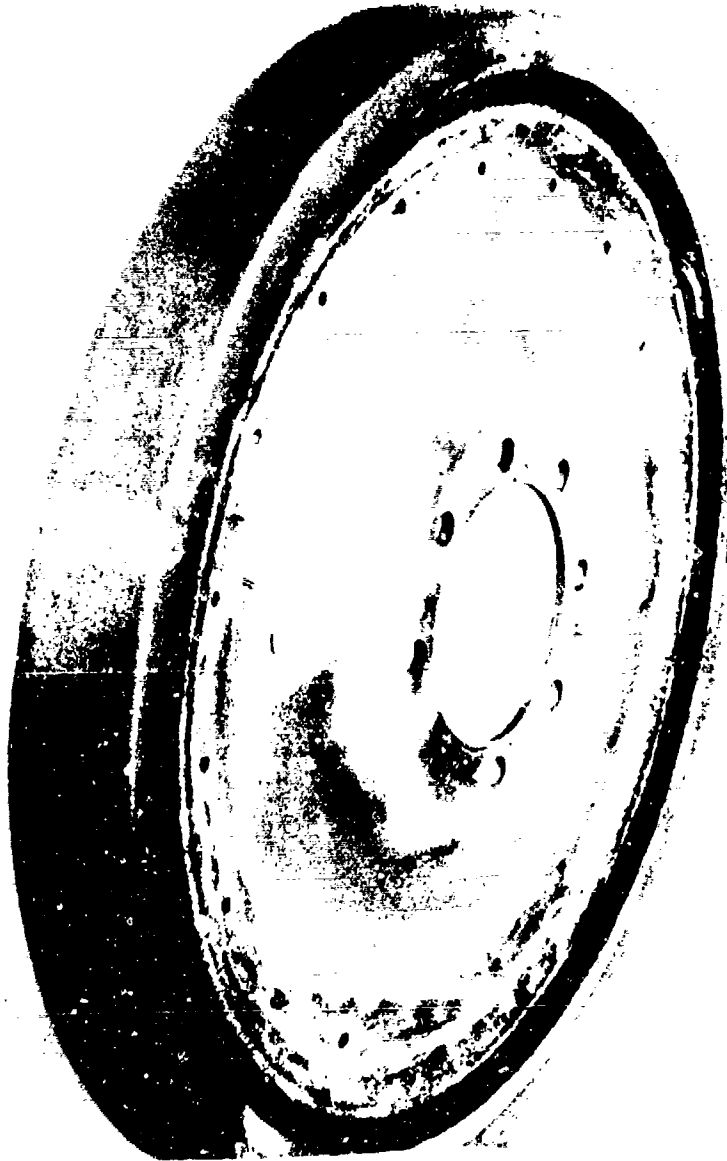
FIGURE 1

2. Engineering Drawing No. 3CP102, Revision A, dtd 13 July 1973, depicts the rim as a continuous joint-free, ring-like structure having a 24-inch O.D., and a 21.63-inch I.D., with a 2.88-inch flange. The material requirement is for a SAE 1040 steel or equivalent. In our investigation, however, we observed that, although the rims met the geometrical (ring-like) requirements, it appeared to be formed from two different materials. Evidence of this was first discovered during visual examination of a Nital etched section from a broken rim. At that time, a distinct light etching band was observed in the fracture area. Further investigation showed that such a band was also present in all the remaining rims and steel shrouded roadwheels (see Figures 1, 2 and 3).

STEEL SHROUDED ROADWHEEL AND LIGHT ETCH BAND  
(2% NITAL ETCH)
